## 5.0 Watershed Inventory Summary

Early in 2012, Applied Ecological Services, Inc. (AES) completed a field inventory of Pike River and its tributaries, existing best management practices (BMPs), ravines, brownfields, and wetlands. Additional data regarding agricultural land, floodways, flood problem areas, and groundwater resources within the watershed were also compiled.

Early in 2012, Applied Ecological Services, Inc. (AES) completed a field inventory of Pike River and its tributaries. All streams and tributaries were assessed based on divisions into “Stream Reaches” (Table 15; Figure 41). Reaches are defined as stream segments having similar hydraulic, geomorphic, riparian condition, and adjacent land use characteristics. Methodology included walking all or portions of the stream reaches, collecting measurements, taking photos, and noting channel, streambank, and riparian corridor conditions. The conditions of each reach of the Pike River were often dictated by the condition of the adjoining tributaries. Numerous municipal stormwater point discharges were also encountered during the inventory but were not surveyed due to time and budget constraints. The direct drainage area c

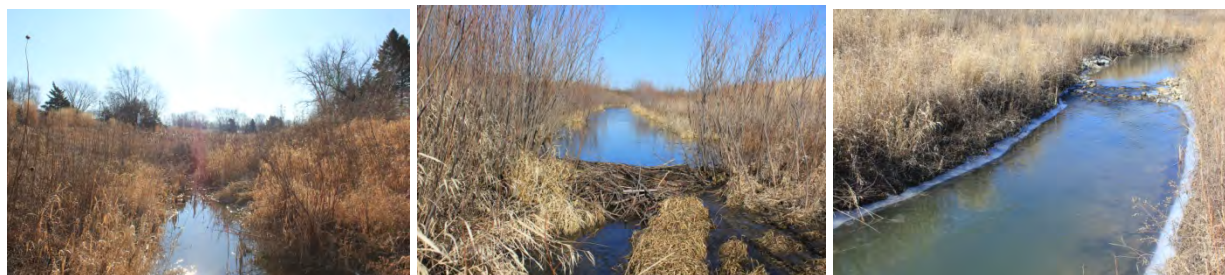
The upper reaches of North Branch Pike River (PR01 through PR05) are bordered by areas of turf, prairie, and wetland areas. Although these reaches are highly channelized, erosion is fairly low in these areas as a result of much of the restoration work that has been done. The channel is roughly 3 to 5 feet wide through these stretches. The channel bottom is comprised of silt and sediment accumulation is low in these reaches. Debris jams are generally not an issue, with the exception of reach PR03. Lower reaches show some invasion by reed canary grass. Reach PR02 is the most sinuous of these upper reaches as it winds its way through a wetland complex, greatly slowing down the flow of the water and reducing downstream erosion.

*North Branch Headwaters (PR01)*

*North Branch Reach 3 (PR03)*

*North Branch Reach 5 (PR05)*

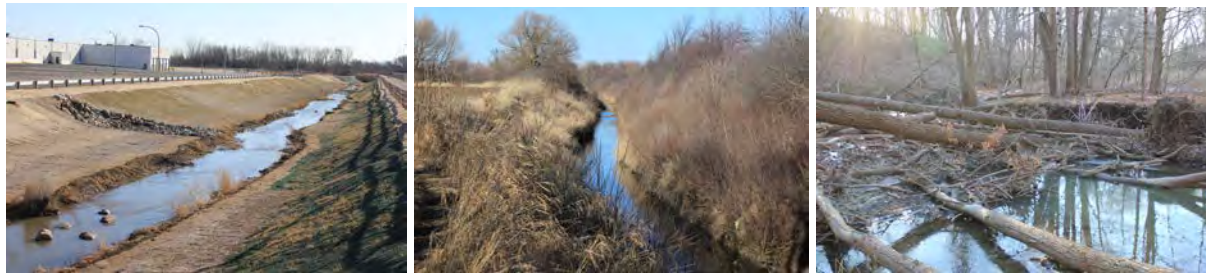
Reaches PR06 and PR07 are bordered by a mix of wetland and old field areas. Conditions of the channel here are similar to the first five reaches with the exception that Reach 6 exhibits moderate levels of erosion. Both reaches show an extensive reed canary grass invasion that needs to be controlled. Reach 7 includes a stretch of land that might be suitable to allow the stream to overtop its banks. Reach PR08 had recently undergone restoration including regarded slopes, riffles, and plantings as part of the Pike River Improvement Project at the time AES completed the field inventory.

Reach PR09 includes a long stretch of the river that runs through agricultural fields and ends where State Highway 31 crosses the Pike River. This reach is highly channelized, with spoil piles on both sides of the banks and moderate levels of erosion throughout. The banks include a very narrow buffer area which is invaded by willows and reed canary grass and the channel is 4 to 6 feet wide.

Between State Highway 31 and County Trunk Highway A lies reach PR10, the last reach of North Branch Pike River before the confluence of South Branch Pike River and Pike River. The riparian area throughout this reach is wooded on both sides of the stream. This reach exhibits no channelization and the stream here is very sinuous, but suffers from excessive amounts of erosion

with the banks reaching heights of six feet above the water level in some areas as well as heavy debris loads from fallen trees.

*North Branch Reach 8 (PR08)    North Branch Reach 9 (PR09)    North Branch Reach 10 (PR10)*

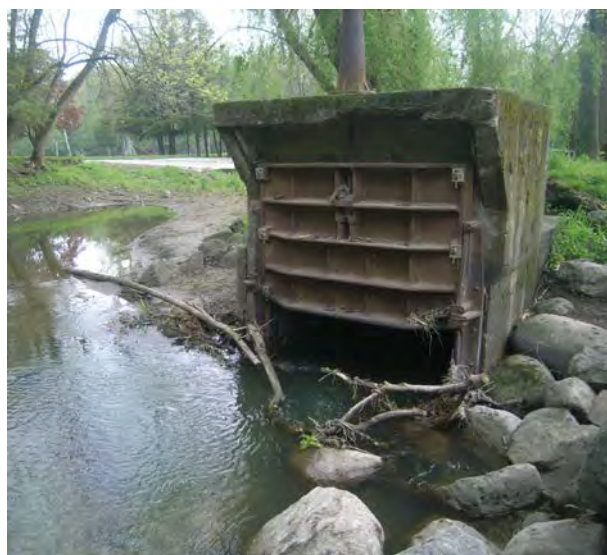
The removal of a dam within Petrifying Springs Park along Pike River Reach 11 was completed late in 2012. The dam was built in 1936, but is no longer being used for its original purpose of irrigating neighboring grounds. Dam removal will allow for fish passage along Pike River as well as alleviate flooding within the park.

*Dam at Petrifying Springs prior to removal in 2012.*

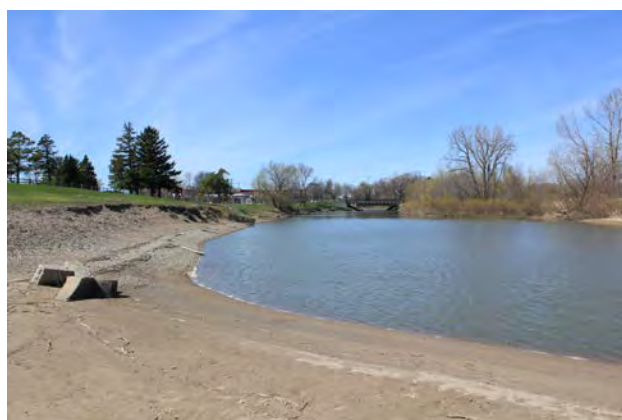
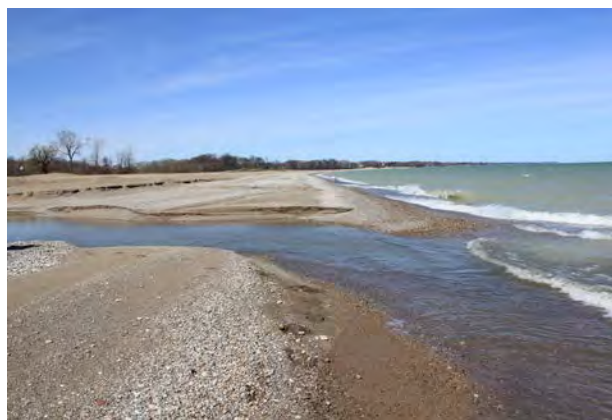
The last reach of Pike River is Reach 17, which extends from the bridge across State Highway 32 at the southern most boundary of Carthage College to the mouth of the Pike at Lake Michigan. PR17 is moderately channelized and eroded. There are noticeable dredge spoils on either side of the banks which act as levees. The right bank exhibits more erosion due to the riparian cover of turf and impervious cover along the bank as opposed to the left bank which consists more of beach cover. There is quite a bit of sediment accumulation where the mouth connects with Lake Michigan as it receives sediment coming in from the lake due to tidal movement as well as the sediment transported from upstream reaches.

*Pike River Reach 17 (PR17). LEFT: Facing upstream toward bridge, RIGHT: The mouth of the Pike at Lake Michigan.*

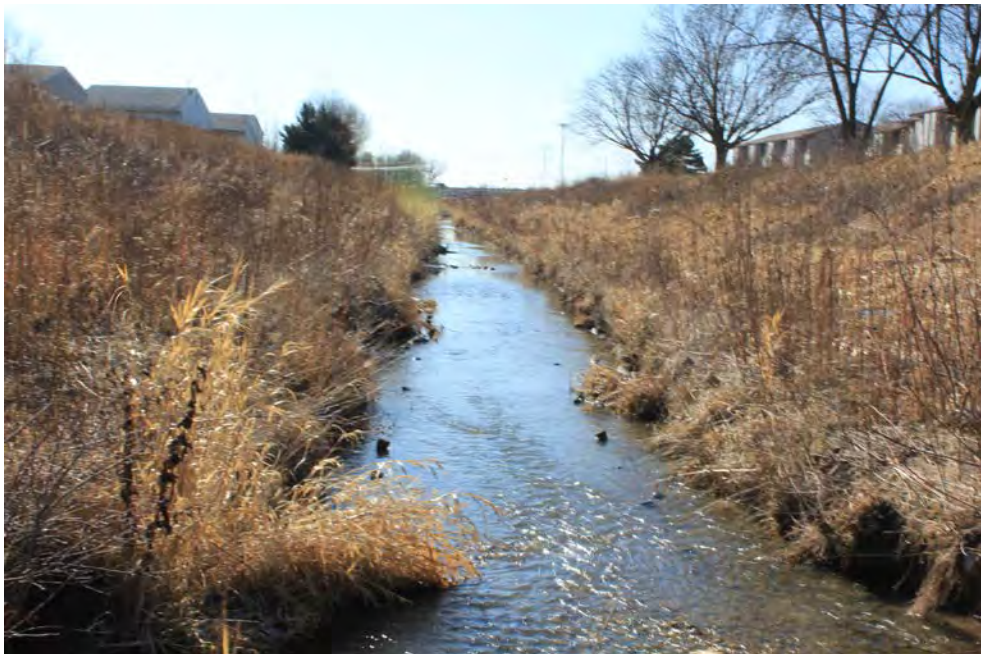
According to the stream inventory, 20% (64,809 lf) of stream and tributary length is naturally meandering; approximately 43% (142,836 lf) is moderately channelized; and 37% (120,903 lf) is highly channelized. The most severe channelization is found along North Branch north of State Highway 20 and

*Channelization along North Branch Reach 4 (PR04)*

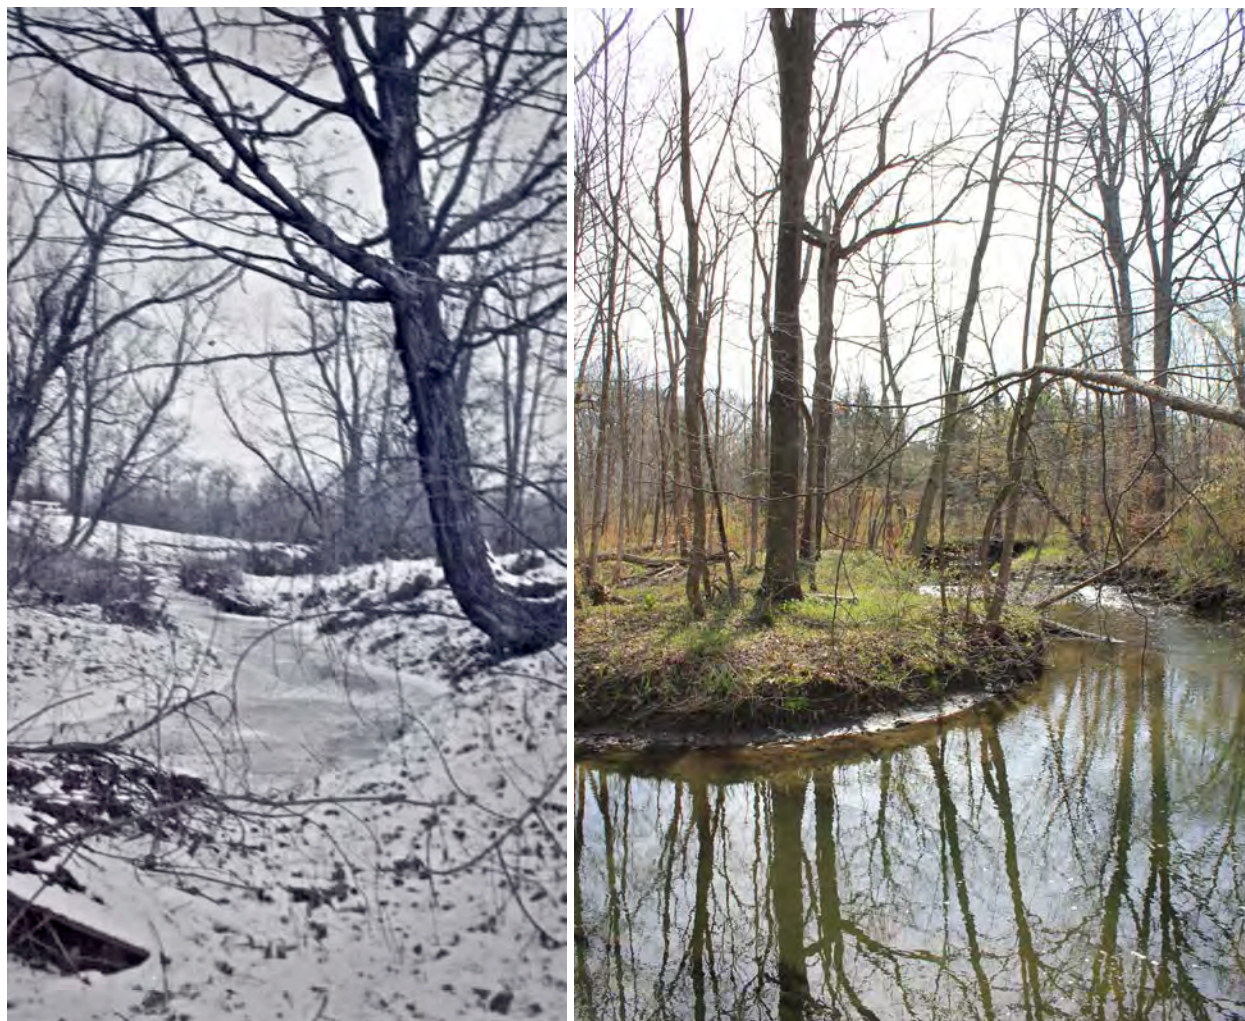
Over the years, Pike River and its tributaries have been channelized, impervious surfaces have increased, and the floodplain has been altered to the extent that the river now takes on larger volumes of water at higher rates with less stream length than it did historically. The photos below, taken at roughly the same location along South Branch at Hawthorn Hollow over seventy years apart depict not only the advances of erosion over time, but the increased channel width and downcutting as well. The riparian area has also been filled in by second growth opportunistic trees and shrubs that historically would have been managed through natural processes such as fire and periodic flooding.

*South Branch in Hawthorn Hollow Nature Sanctuary - LEFT: a 1940 photo, courtesy Hawthorn Hollow Nature Sanctuary. RIGHT: the same location in 2012.*

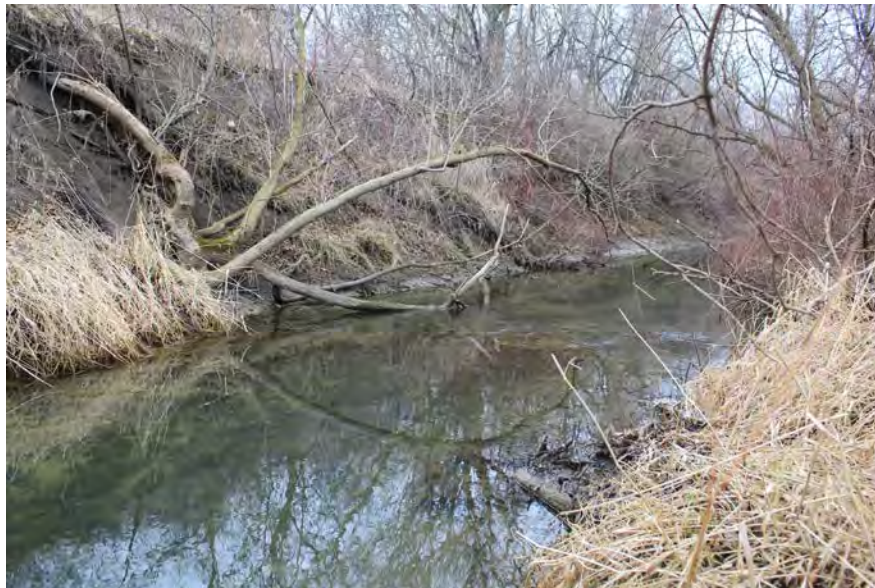
Approximately 41% (133,907 lf) of the total stream and tributary length exhibits no or low bank erosion while moderate erosion is occurring along 54% (179,236 lf) of streambanks. Highly eroded streambanks are observed along Pike River between State Highway 31 and County Trunk Highway A (PR10) and along the last three reaches of South Branch before it joins Pike River (PC05, PCHH, and PC06) accounting for 5% (15,404 lf) of the total stream length. These reaches are considered “Critical Areas” because they are actively contributing significant sediment loads downstream.

*Excessive erosion along part of South Branch Reach 4*

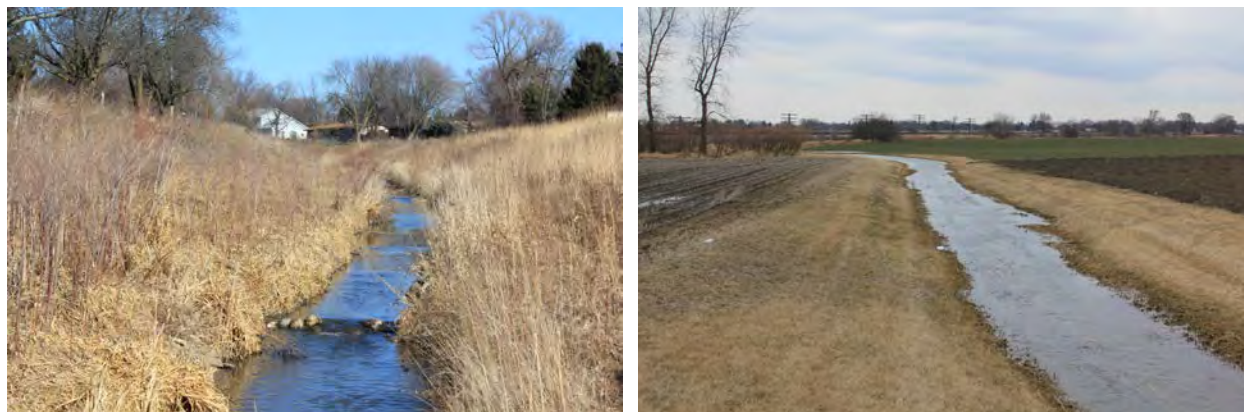
*LEFT: Restored riparian area along North Branch Reach 4. RIGHT: Virtually nonexistent riparian corridor along South Branch Tributary R.*

Altered hydrology and invasive species are the leading causes of degraded conditions in the riparian areas. Common reed (*Phragmites australis*), reed canary grass (*Phalaris arundinacea*), sandbar willow (*Salix interior*), box elder (*Acer negundo*), and eastern cottonwood (*Populus deltoids*) are among the most abundant and problematic invasive plants. Fortunately, ecological restoration helps eradicate these species and encourages native plant establishment. The Action Plan section of this report lists and prioritizes opportunities for improving riparian areas through ecological restoration.

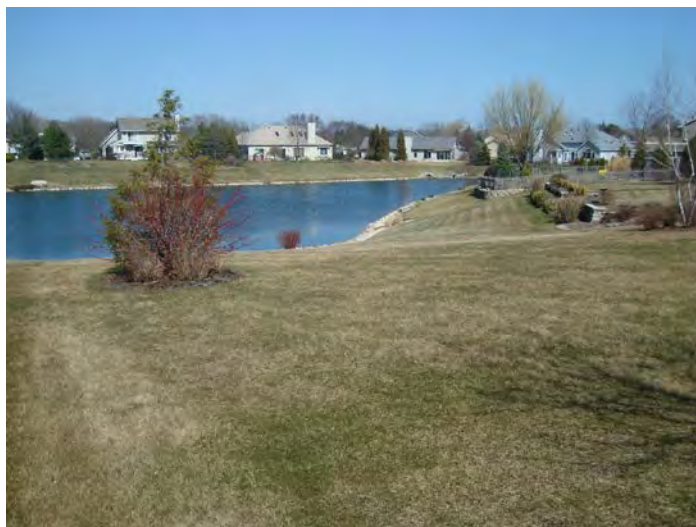
The typical wet bottom detention basin in Pike River watershed has an inlet and an outlet, fairly steep turf grass side slopes, and does little to improve water quality (See photo, right). Wetland bottom detention basins differ only in that they are shallow enough to be dominated by emergent plants. Typically both types of basins were designed with homeowner aesthetics in mind rather than water quality or wildlife habitat concerns.

*Typical wet bottom detention basin located southwest of Kr County Line Rd and County Trunk Highway Y.*

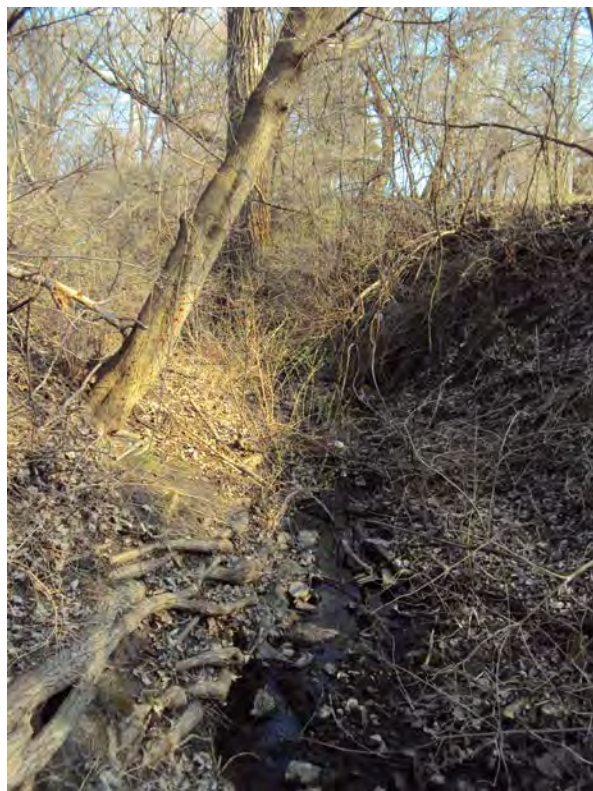
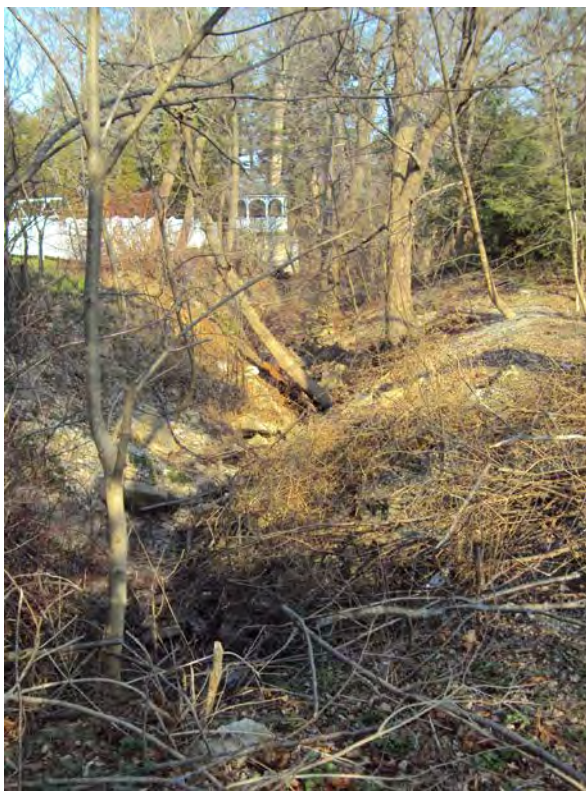
Over time, urban development and the increase in impermeable surfaces over much of the Pike River watershed has increased both the amount and force of water being released into many of these ravines. Particularly in the urban development along the coast of Lake Michigan in both Racine and Kenosha Counties, stormwater outfalls have often been diverted directly into ravines. The force and volume of water moving through these ravines can often cause headcutting (also known as knickpoints) where there is a sudden change in stream elevation and exacerbating erosion downstream, eventually leading to channel blowouts. Unless stabilized, headcuts can migrate upstream over time, causing additional damage and erosion.

*Potential ravine restoration sites. LEFT: Ravine east of RCOC Park (32B), RIGHT: Ravine east of Lakeshore Dr (39A).*

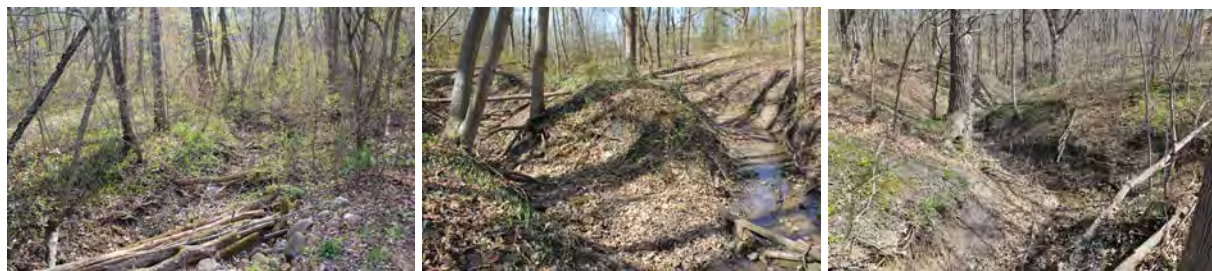
There are also three ravines located in the center of the watershed close to where South Branch joins Pike River. The first of these ravines, Hawthorn Hollow Ravine (42F), is located off the west bank of South Branch Hawthorn Hollow Reach (PCHH) and drains from an adjacent agricultural field. The stream downcutting has caused moderate erosion in this ravine. North of this ravine off of School Tributary to South Branch (PCST) is another ravine – the School Tributary Ravine (42G). This ravine actually drains the same agricultural field as Hawthorn Hollow Ravine. This ravine begins as two channels that combine to form one highly eroded ravine with a headcut already formed. This ravine contributes large amounts of sediment from the adjacent agricultural field to South Branch.

*Hawthorn Hollow Ravine (42F)      School Tributary Ravine (42G)      South Branch Reach 5 Ravine (42H)*

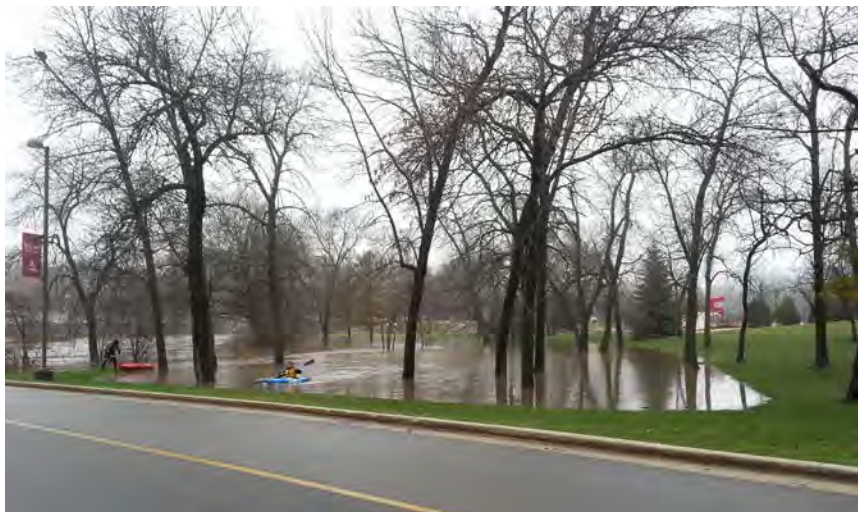
*Flooding in April 2013 along Pike River on Carthage College Campus.  
Source: Matthew Gundlach.*
