## 5.0 Watershed Inventory Summary

Early in 2012, Applied Ecological Services, Inc. (AES) completed a field inventory of Pike River and its tributaries, existing best management practices (BMPs), ravines, brownfields, and wetlands. Additional data regarding agricultural land, floodways, flood problem areas, and groundwater resources within the watershed were also compiled.

Early in 2012, Applied Ecological Services, Inc. (AES) completed a field inventory of Pike River and its tributaries. All streams and tributaries were assessed based on divisions into “Stream Reaches” (Table 15; Figure 41). Reaches are defined as stream segments having similar hydraulic, geomorphic, riparian condition, and adjacent land use characteristics. Methodology included walking all or portions of the stream reaches, collecting measurements, taking photos, and noting channel, streambank, and riparian corridor conditions. The conditions of each reach of the Pike River were often dictated by the condition of the adjoining tributaries. Numerous municipal stormwater point discharges were also encountered during the inventory but were not surveyed due to time and budget constraints. The direct drainage area c

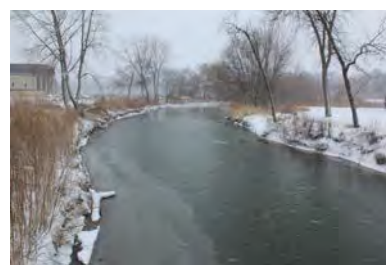
*Pike River Reach 16 (PR16)*

Reach 16 includes the section of the Pike River within Carthage College. Here the channel extends to about 15 feet wide. Bank height and erosion levels vary throughout this section of the reach with some highly eroded sections apparent. Many invasive woody species are present here and debris jams are moderate, mostly from fallen trees within the stream. No riffles were observed and the riparian cover consists mostly of mowed turf grass, with some wetland and wooded areas. In addition, reach 16 and 17 act as an estuary to Lake Michigan.

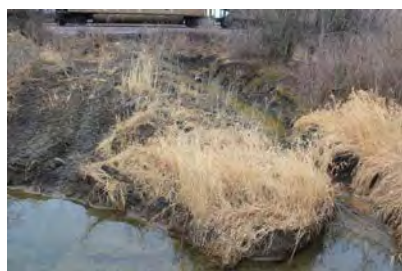
*South Branch Reach 3 (PC03)*

South Branch Reach 2, 3, and 4 (PC02, PC03, and PC04) run from Reach 1 to the boundary of the Hawthorn Hollow Nature Sanctuary and are highly channelized with spoil piles evident on both banks and no riffles within the channel. The channel width is about 4 feet with a bottom comprised of silt. The banks are dominated by reed canary grass and the riparian cover includes wetlands, agricultural fields, turf grass, and pavement. Reach 3 has moderate erosion and has high debris loads from fallen trees, while Reach 4 has excessive erosion with bank heights as high as six feet.

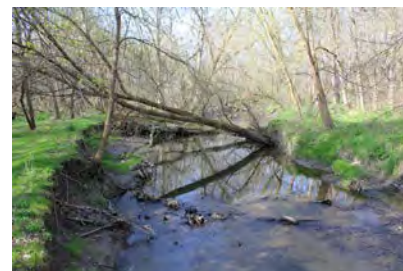
*Hawthorn Hollow Reach (PCHH)*

The Hawthorn Hollow Reach of South Branch (PCHH) and South Branch Reach 6 (PC06), unlike the southern reaches of South Branch are not channelized. PCHH and PC06 are both highly eroded and have moderate levels of both sedimentation and debris jams. The channel bottom here consists of a mix of gravel and cobble with a width of 12 to 15 feet and the riparian area is entirely wooded.

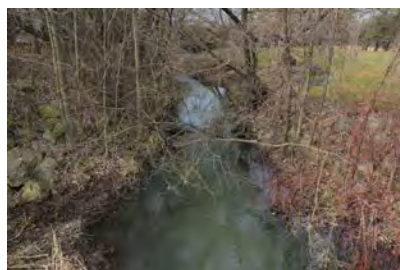
*Waxdale Creek (PRWC)*

Waxdale Creek (PRWC), another tributary, is located in the northwestern portion of the watershed and is listed as an impaired stream by the EPA for high amounts of sedimentation and degraded

habitat. The channel is 2 to 6 feet wide with a silt substrate. Both channelization and bank erosion are moderate for this stream as well as moderate debris loading in the channel. The riparian cover is mostly wooded with turf and wetland areas also present. One industrial point source was noted on this tributary – S.C. Johnson & Son Inc., located in Mt. Pleasant. The plant discharges to Waxdale Creek. In 1983, a toxic spill resulted in aquatic toxicity and fish kills along Waxdale Creek and the adjoining section of the North Branch. No other fish kills have been noted for this location and the pollutants have since been removed.

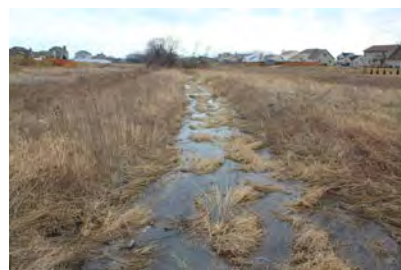
*Chicory Creek (PRCC)*

Chicory Creek (PRCC) and Lamparek Ditch (PRLD) both join North Branch Pike River along North Branch Reach 9. Both tributaries are highly channelized, have a silt bottom and little sediment accumulation or debris jams. Chicory Creek varies in width from 0.5 to 10 feet wide, widening as it moves downstream, with no erosion upstream, but moderate levels downstream. The riparian area consists of residential lawns, wooded areas, and agricultural fields. Lamparek Ditch has low levels of erosion and a small wooded buffer area with agricultural fields dominating beyond. Channel width is between 2 and 3 feet here.

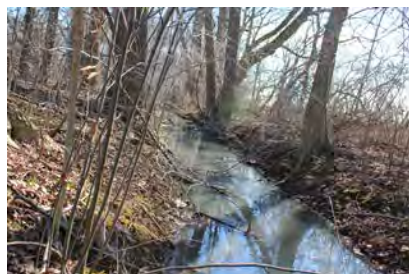
*Nelson Creek (PRNC)*

On the eastern side of the watershed there are three named tributaries that feed into the Pike River: Nelson Creek, Sorenson Creek, and Kenosha Branch. Nelson Creek is moderately channelized with no pools or riffles. Both the degree of erosion and sediment accumulation for this tributary are low. Moderate levels of debris jams are present and the riparian cover is comprised of a mix of wooded areas, wetlands, row crops, and turf grass.

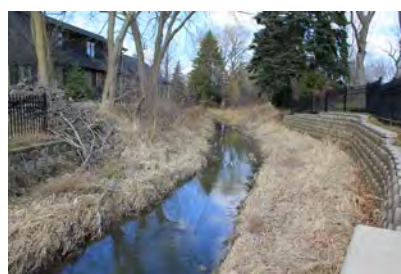
*Sorenson Creek (PRSC)*

Sorenson Creek and Kenosha Branch are both moderately channelized and show moderate levels of erosion with a silt bottom. The channel width of both tributaries is between 3 and 6 feet and both exhibit a moderate level of sediment accumulation. Kenosha Branch has a few more pools and riffles than does Sorenson Creek. The riparian cover of Sorenson Creek is mostly wooded with some turf grass sections while the riparian cover of Kenosha Branch is fairly evenly split between wooded, turf grass, and wetland areas.

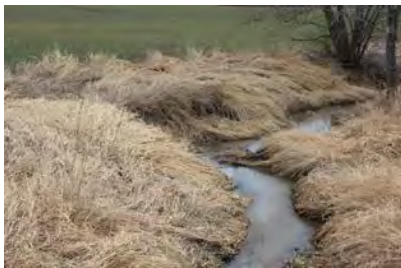
*School Tributary (PCST)*

School Tributary and Airport Branch are both highly channelized, with spoil piles present on both banks of School Tributary. Both exhibit moderate levels of erosion, with no sinuosity or riffle-pool development. Both tributaries also have a silt channel bottom and have low amounts of debris jams and sediment accumulation. The riparian cover of School Tributary is entirely agricultural land with a very small buffer made mostly of reed canary grass. Airport Branch's riparian cover is mostly old field with turf grass and wooded areas filling out the balance.

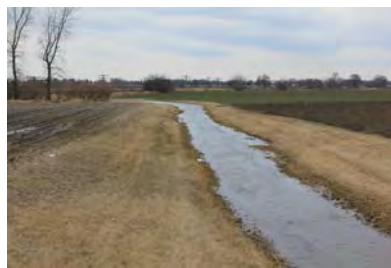
*Somers Branch (PCSB)*

School Tributary, Somers Branch, and Airport Branch are all tributaries of South Branch Pike River in the western and southern portions of the watershed. Somers Branch is moderately channelized with low levels of erosion and sediment accumulation. The channel width is fairly narrow (1 to 2 feet wide) and the dominant substrate is silt. The riparian cover for this reach is predominantly row crops with turf grass and wooded patches making up the balance. Somers Branch has a heavy debris load and the banks are dominated with cattails and reed canary grass.

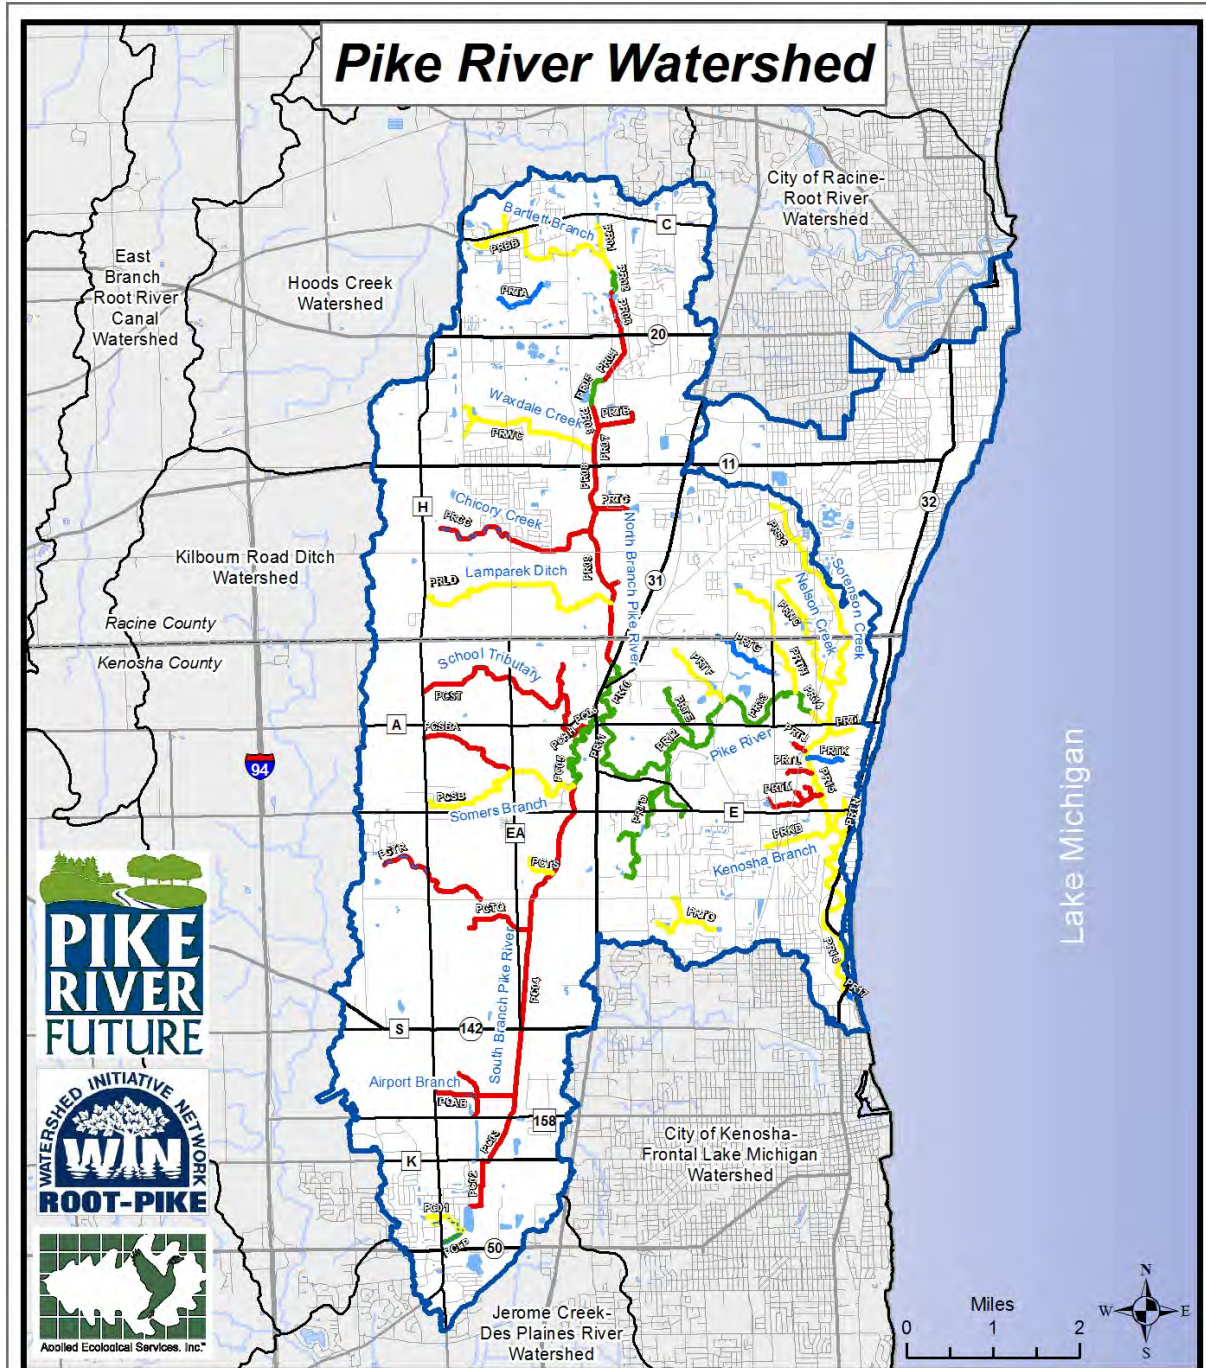
**Fig. 42: Degree of Channelization**

According to the stream inventory, 20% (64,809 lf) of stream and tributary length is naturally meandering; approximately 43% (142,836 lf) is moderately channelized; and 37% (120,903 lf) is highly channelized. The most severe channelization is found along North Branch north of State Highway 20 and

Channelized areas present opportunities for Management Measure projects such as artificial riffle and pool restoration and regrading or breaking of adjacent spoil piles for reconnection of the stream to adjacent floodplains. Table 16 and Figure 42 summarize and depict the location and severity of channelized stream and tributary reaches in the watershed. The Action Plan section of this report addresses opportunities for improving many of these channelized stream reaches.

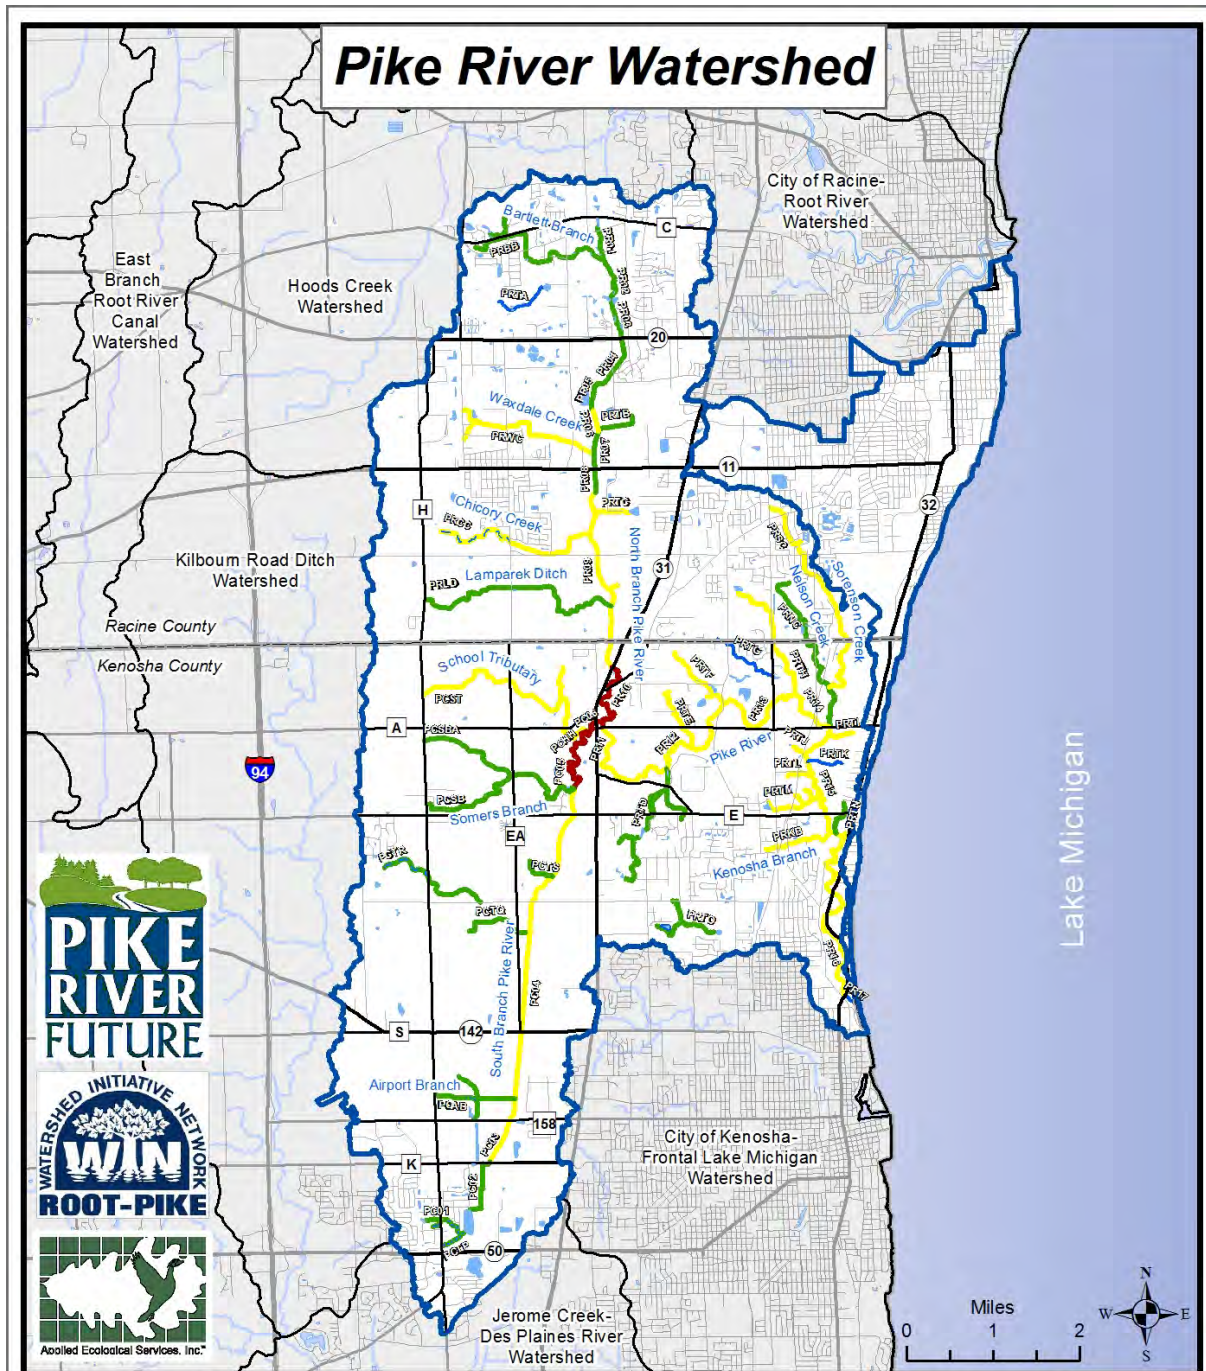
Fig. 43: Degree of Erosion

Approximately 41% (133,907 lf) of the total stream and tributary length exhibits no or low bank erosion while moderate erosion is occurring along 54% (179,236 lf) of streambanks. Highly eroded streambanks are observed along Pike River between State Highway 31 and County Trunk Highway A (PR10) and along the last three reaches of South Branch before it joins Pike River (PC05, PCHH, and PC06) accounting for 5% (15,404 lf) of the total stream length. These reaches are considered “Critical Areas” because they are actively contributing significant sediment loads downstream.

All highly eroded and some moderately eroded streambanks provide excellent opportunities for streambank stabilization projects. The location and severity of streambank erosion in the watershed is summarized in Table 17 and depicted on Figure 43. The Action Plan section of this report addresses and prioritizes opportunities for reducing streambank erosion.

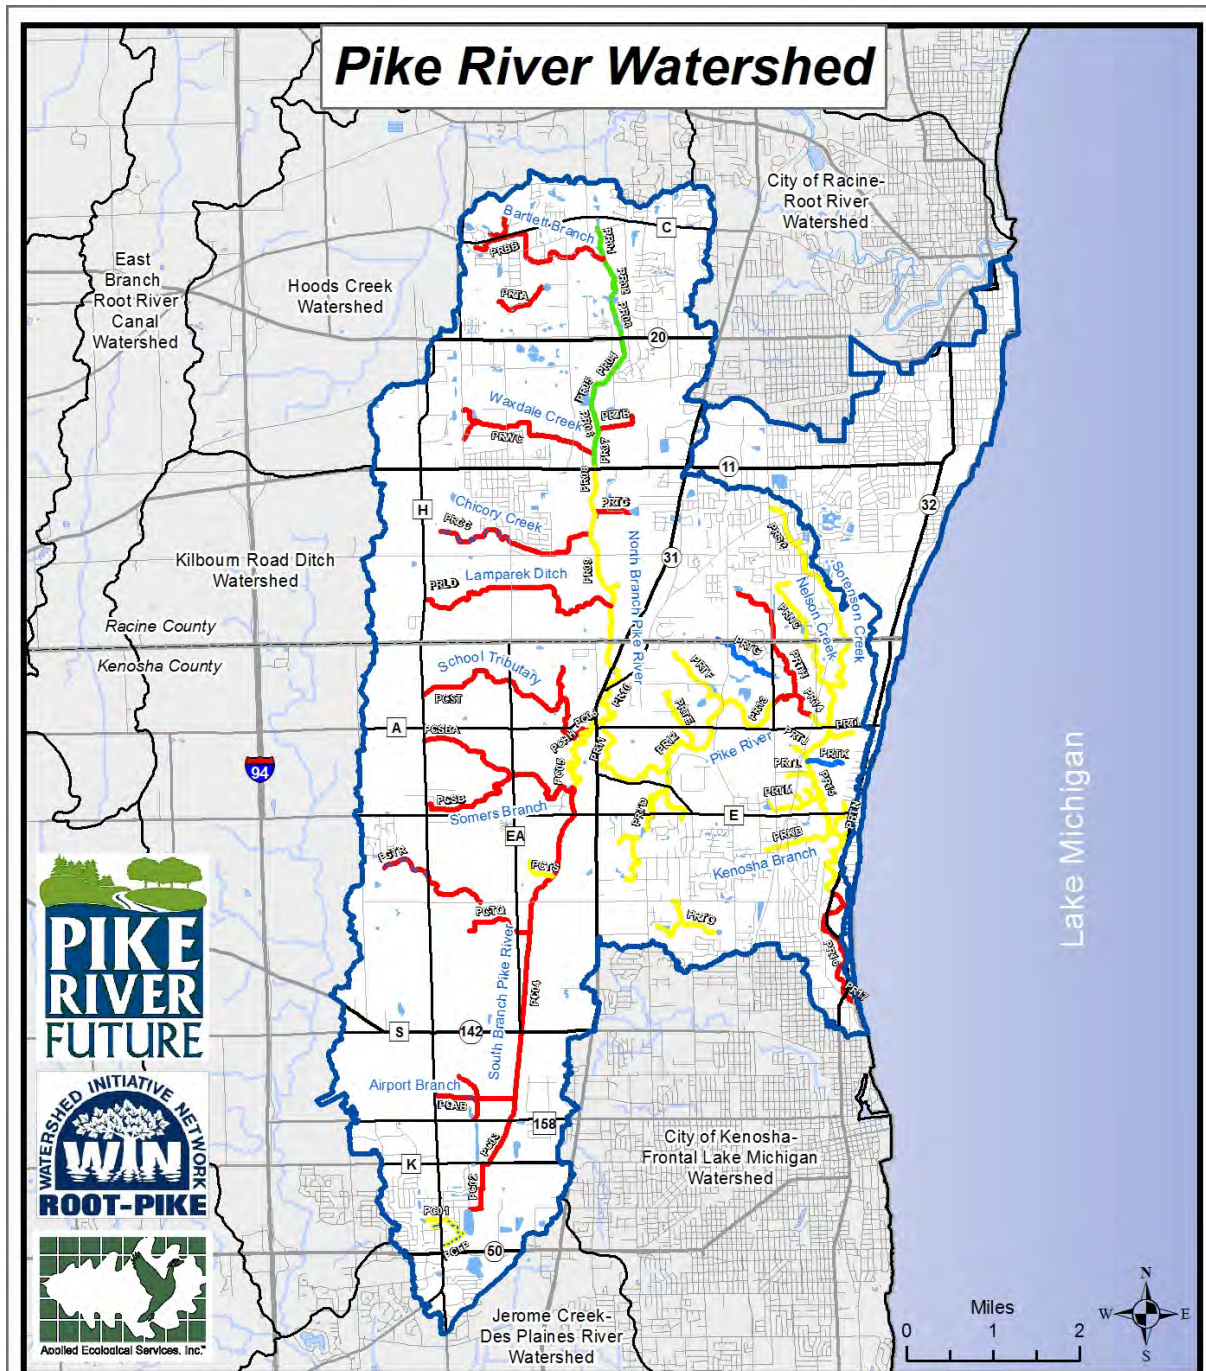
**Fig. 44: Ecological Condition of Riparian Areas**

The riparian zone within roughly 100 feet of each streambank along the streams and tributaries in the watershed were assessed (Figure 44). Of the 332,191.2 linear feet of stream for which the riparian area was assessed, 166,922.8 lf (50%) is considered "Poor" ecological quality, 148,445.2 lf (45%) of the riparian area is "Average" ecological quality, and the remaining 16,823.2 lf (5%) is "Good" ecological quality (Table 18, Figure 44). The majority of poor quality areas are located along the western half of the watershed in areas that have experienced the most human alteration due to agricultural uses. Average quality riparian areas are located within the central and eastern portions of the watershed where the land has been less heavily manipulated by humans, but the plant communities remaining have been degraded to some extent, most typically by invasive species. Riparian areas in good condition are all located north of State Highway 11 in areas where ecological restoration has occurred.

Altered hydrology and invasive species are the leading causes of degraded conditions in the riparian areas. Common reed (*Phragmites australis*), reed canary grass (*Phalaris arundinacea*), sandbar willow (*Salix interior*), box elder (*Acer negundo*), and eastern cottonwood (*Populus deltoids*) are among the most abundant and problematic invasive plants. Fortunately, ecological restoration helps eradicate these species and encourages native plant establishment. The Action Plan section of this report lists and prioritizes opportunities for improving riparian areas through ecological restoration.

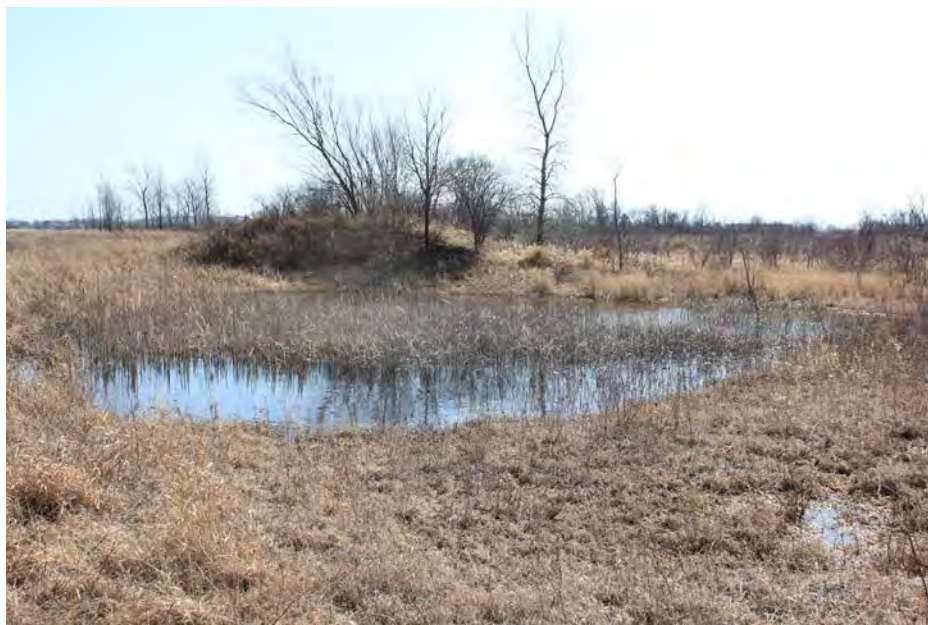
*Part of a wetland complex at the northern edge of the watershed just south of County Trunk Highway C.*

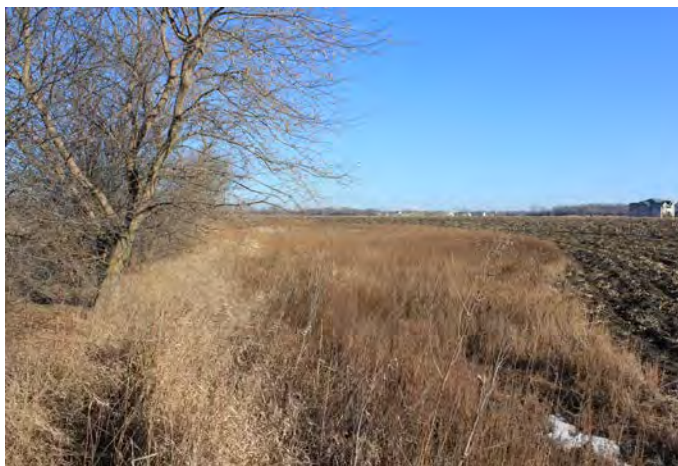
- Site #1 (photo, right) is 22.3 acres located at the headwaters of North Branch Pike River in an area identified for future residential development,

*Site #1: Potential wetland restoration at headwaters of North Branch Pike River.*

making it an excellent location to incorporate wetland restoration as part of the residential development surrounding the site. It lies on agricultural land that is likely drained by tiles and is part of the Green Infrastructure Network.

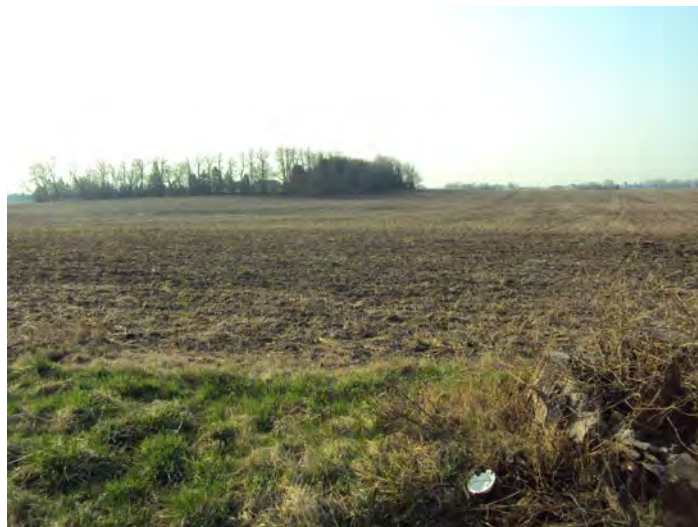
- Site #10 (photo, right) is a 67.7 acre drained wetland complex located at the headwaters of Lamparek Ditch. This relatively large site is a good candidate for a future wetland restoration and would also extend the Green Infrastructure Network to include the headwaters of this tributary.

*Site #10: Potential wetland restoration at headwaters of Lamparek Ditch.*

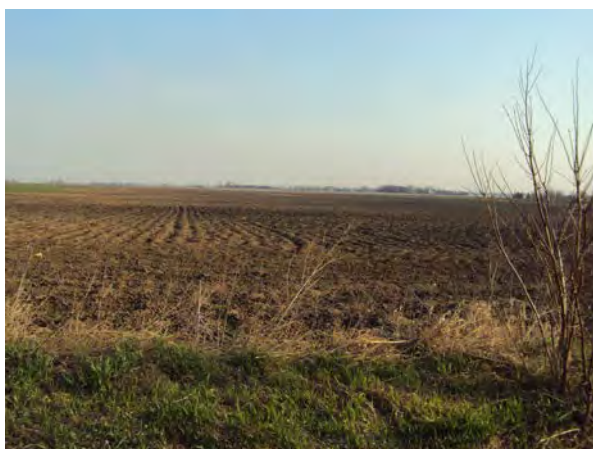
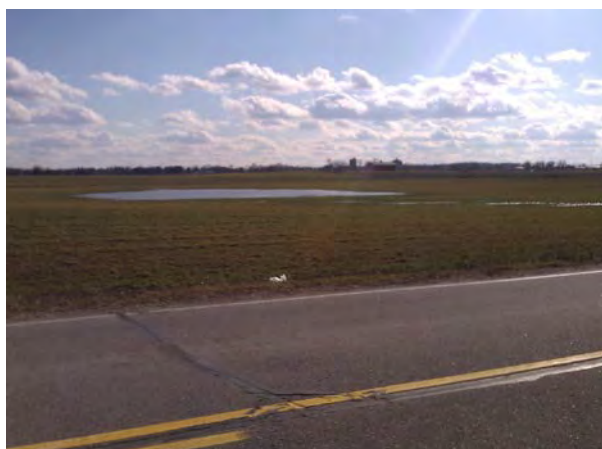
- Site #13 (photo, below left) is a 19.3 acre potential wetland restoration site also located near the headwaters of Lamparek Ditch north of County Line Rd and west of County Highway H. Wetland restoration on this site would also extend the Green Infrastructure Network for Pike River.
- Site's #18 (photo, below right) and 19 are 29.9 and 39.8 acres, respectively. These historic wetland complexes are located along Somers Branch Tributary A and are part of the Green Infrastructure Network. Both potential wetland restoration sites include portions of lands that are reserved for open space on future land use maps.

*LEFT: Site #13 near the headwaters of Lamparek Ditch. RIGHT: Site #18 along Somers Branch Tributary A.*

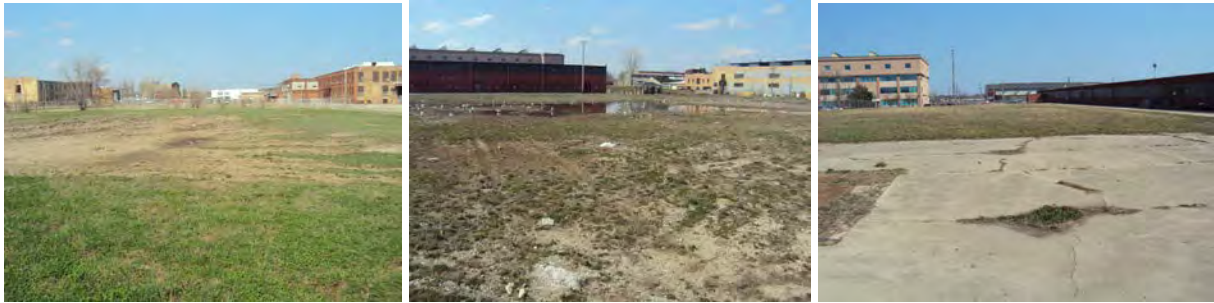
Four brownfield opportunities exist within Pike River watershed, all of which fall within the City of Racine in the Direct Drainage area (Figure 49). The first is a vacant lot located along the west side of Clark Street between 14<sup>th</sup> Street and 15<sup>th</sup> Street. The Clark Street Brownfield Site (16A) abuts the railroad tracks and consists of spotty areas of turf grass and bare dirt.

Another brownfield opportunity, Phillips Avenue Brownfield Site (16C) can be found where 18<sup>th</sup> Street and Phillips Avenue meet, just off the northwest corner of South Memorial Drive and De Koven Avenue. This site includes the area between South Memorial Drive and Phillips Avenue as well as an adjacent field immediately west of Phillips Avenue. This site includes spotty grass, bare dirt, and a depressional area holding water at the time of the site visit in spring of 2012. Just west of this site, is another potential brownfield opportunity located northeast of the intersection of Taylor

Ave and 18<sup>th</sup> Street. The 18<sup>th</sup> Street Brownfield Site (16D) extends eastward along the south end of the Racine County Workforce lot and consists of bare grass and areas of old concrete.

*Clark Street Brownfield Site (16A) Phillips Ave Brownfield Site (16C) 18<sup>th</sup> Street Brownfield Site (16D)*

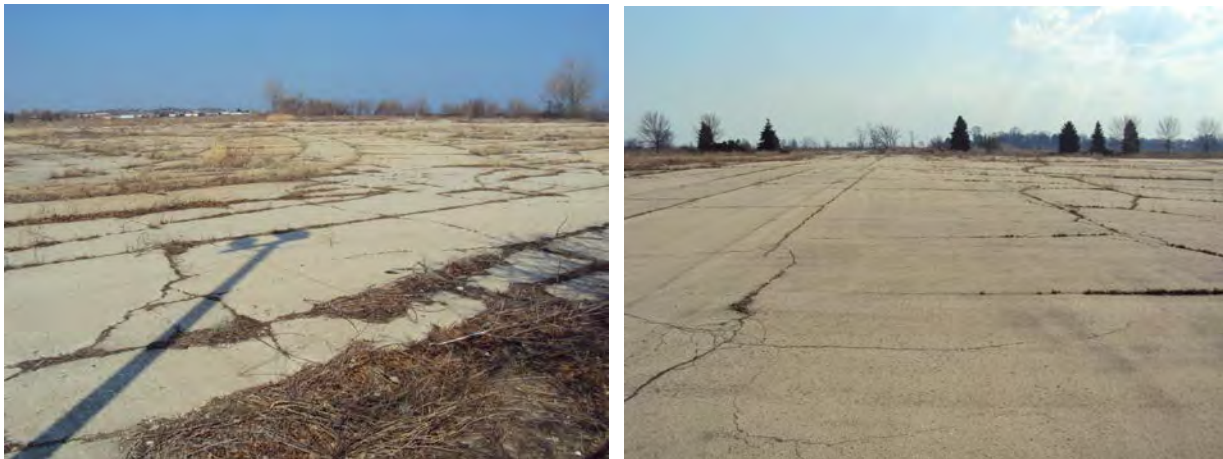
The last of the brownfield opportunity sites is located between Sheridan Road and Lake Michigan and 25<sup>th</sup> Street and Larson Street. The Case Corporation produced agricultural and construction equipment here at one time, but currently the site is vacant. By far the largest brownfield opportunity at around 80 acres, the Case Brownfield Site (25A) is covered with old paved surfaces leftover from its former use with only sporadic bits of weedy vegetation. The eastern side of this site, adjacent to Lake Michigan sits on fill; it is apparent that this area used to be a ravine.

*Case Brownfield Site (25A) along Lake Michigan.*
